**Conservation Area and
Character Appraisal for Wooler**

Proposed Conservation Area Appraisal

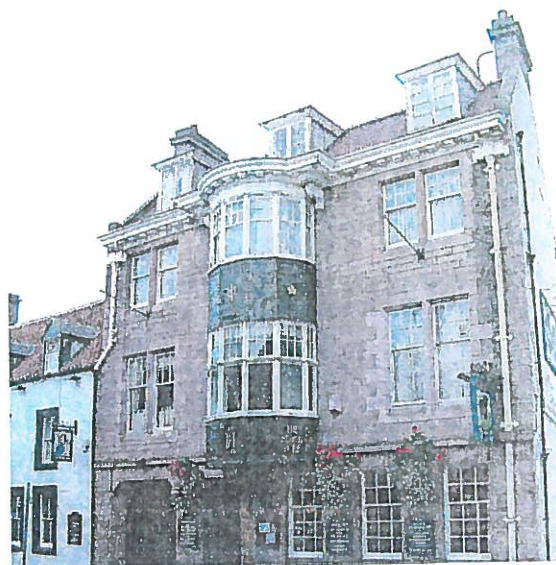
The Black Bull Hotel

Firstly, the listed Black Bull Hotel, which originated in the 17th century, but rebuilt in 1910, in the 'Arts and Crafts' style, and is 3 storeys high, with a prominent 2 storey oriel window, and unusual black painted finish with applied gold motifs. The listed Angel Inn is of historic interest and was originally built in the 17th century and is

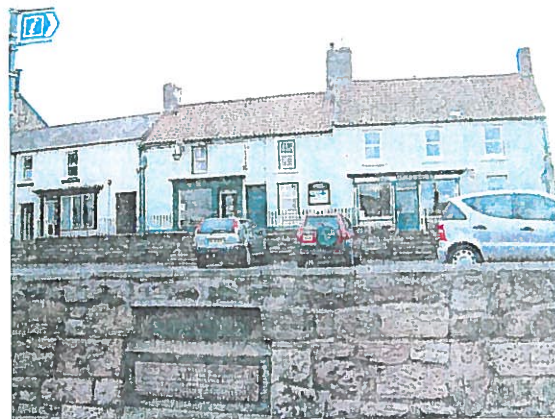
Properties set back to allow more space for markets

Wooler's pattern of growth resulted from a clustering of development around the intersection of five roads including High Street, Church Street, Cheviot Street, Ramsey's Lane and The Peth. The High Street became the centre for trade and focused on The Market Place. This area was formed by the setting back of properties to allow extra space to accommodate fairs and markets.

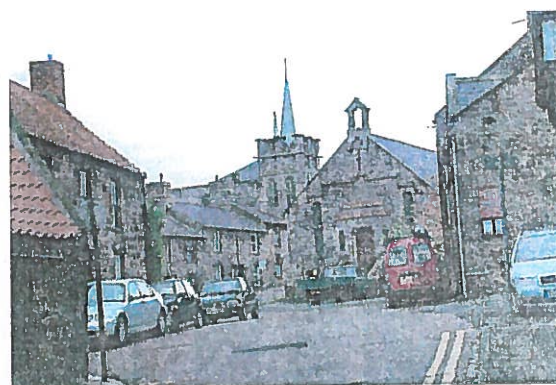
Sandstone gives visual unity to the differing building forms in the Wooler townscape.

Development on the periphery of the settlement was loose knit with a lower density. Townscape in the central area has a distinctive organic character, with a variation of heights and styles. However, the general predominance of sandstone as a building material creates a visual unity to the street scene.

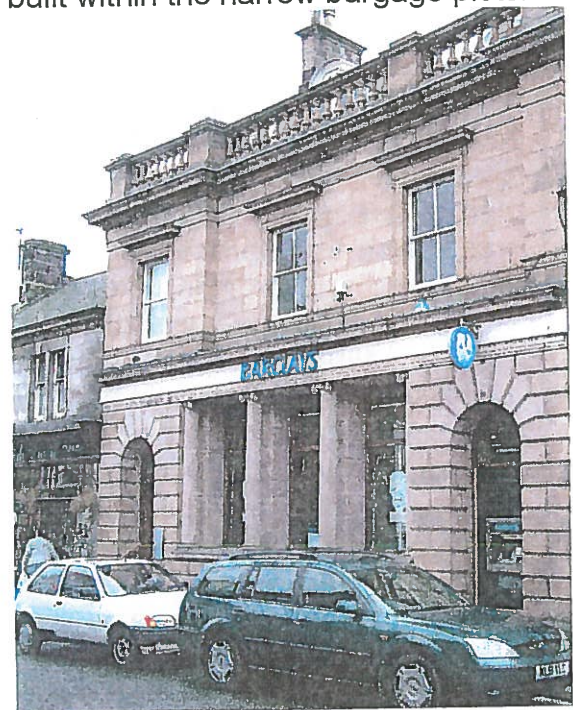
Barclay's Bank, High Street, Wooler

The listed Barclay's Bank on High Street is particularly prominent with its distinctive classical style including rusticated stone finish on the ground floor and ionic columns, contrasting with the modest scale and plain detailing of the surrounding buildings.

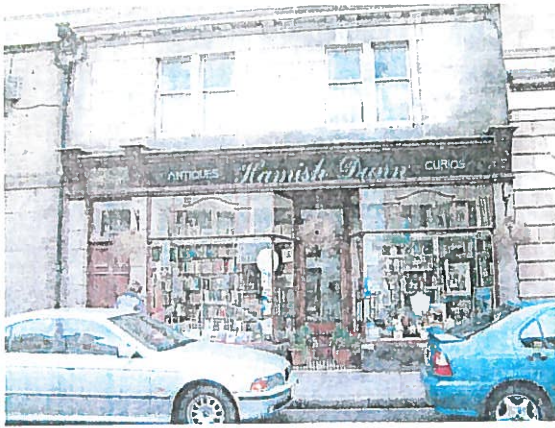
The elegant shop front of Hamish Dunn in the High Street

Old shop fronts add another important visual dimension to the street scene contributing their own particular variety and interest. Not only grander shop fronts such as Hamish Dunn Antiques, but a number of attractive modest 19th and early 20th century unspoilt shop fronts. Although the spaces between buildings varies, the main part of High Street is of medium width with slight curves in the road giving a greater sense of enclosure to the already well contained street scene, closing middle distant vistas. A narrowing of the road creating a visual pinch point to the northwest, further enhances this enclosure. This distinctive feature emphasises the contrast and sudden

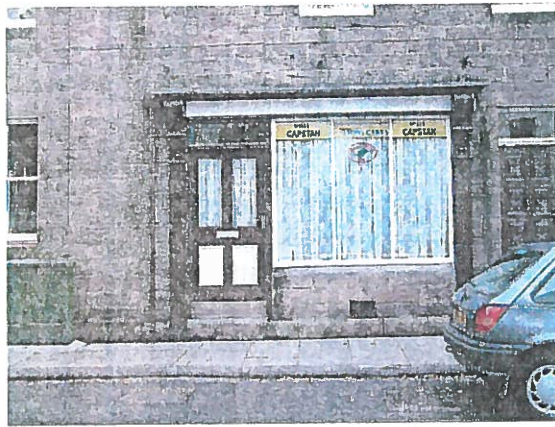
An attractive modest Victorian shop front

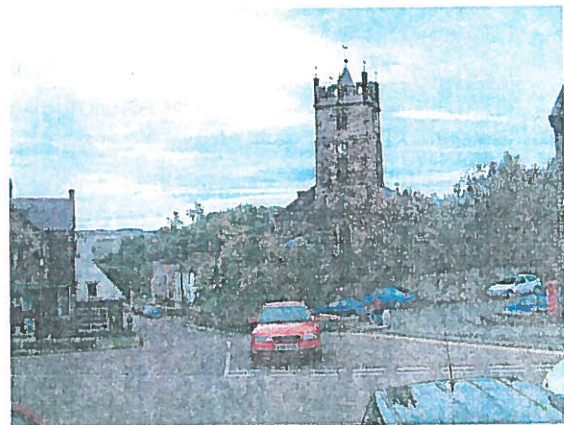
St Mary's Church in its sylvan setting

St Mary's Church is the most distinctive building in the street scene. It is listed, and was built on earlier foundations in 1765 in the Perpendicular style and Gothicised in 1873. The Church is a major landmark, with its elevated, robust stone building form and steep gables surmounted by a modest tower.

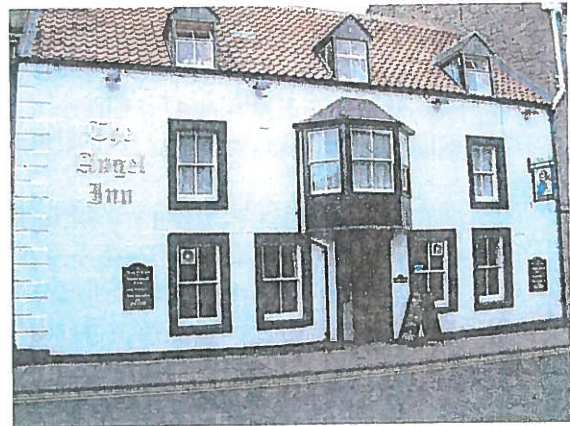
distinct from adjoining stone properties being painted white with black window surrounds, a pantile roof and prominent oriel window over the front door.

The Angel Inn

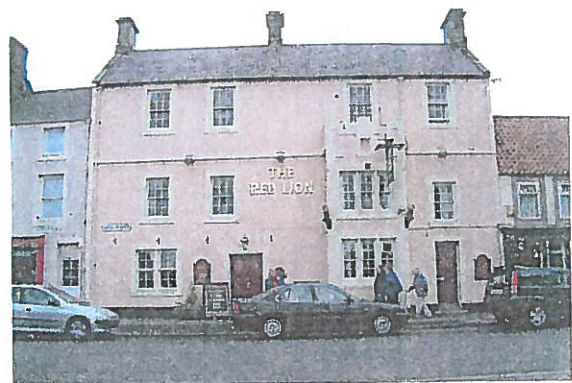
The Red Lion Hotel located in the High Street

The listed Red Lion is distinctive, being 3 storeys high and one of the tallest buildings in the street scene. It dates from 1671, is stucco finished with a slate roof, and has a robust 2-storey late 19th century bay window with a castellated parapet.

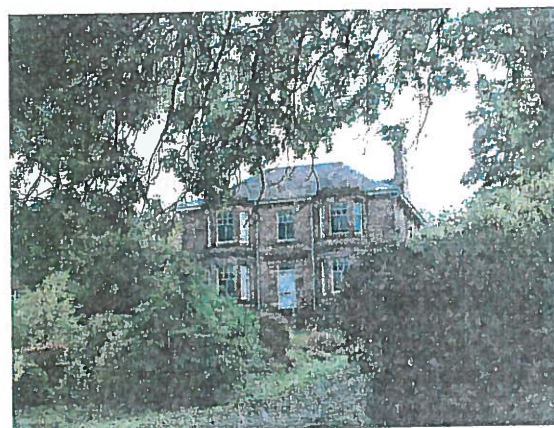
Developments on Ryecroft Way and part of Queen's Road are mainly of large semi-detached or detached Victorian or Edwardian houses set in large gardens with fine mature trees, high hedges and walls, creating an attractive leafy suburb. Buildings are of stone with slate roofs, steep gables and tall chimneys.

Queens Road – a detached house set in large gardens

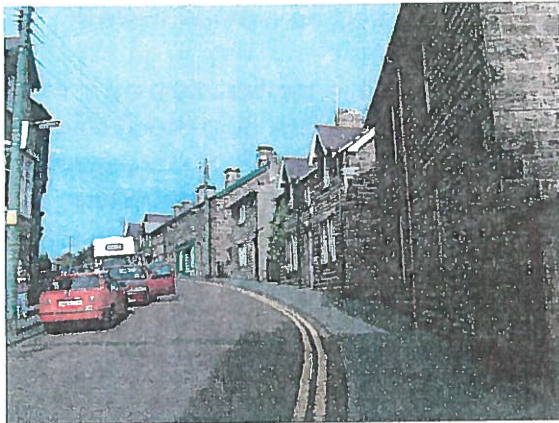
Higher density development along Glendale Road. The buildings are mainly built of stone with plain detailing, some bay windows and steep stepped gables giving articulation and interest to the roofline. The carriageways are fairly wide giving an air of spaciousness to the street scene. There are medium to small front gardens which are well defined by hedges or walls with some landscaping including flowers shrubs and some trees.

The south end of Glendale Road towards High Street has a strong sense of enclosure with close-knit dwellings set on the edge of the pavement creating an intimate street scene as it curves upwards to the north.

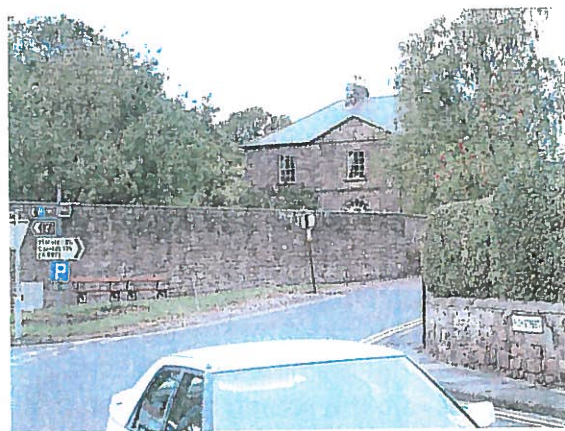
Loreto Guest House, Ryecroft Lane

Adjoining is another key building in the street scene, 'Loreto's', set back behind high stone walls. This fine listed building was designed in the classical style in the late 18th century, as a large 3 bay ashlar stone town house with a pedimented centre bay.

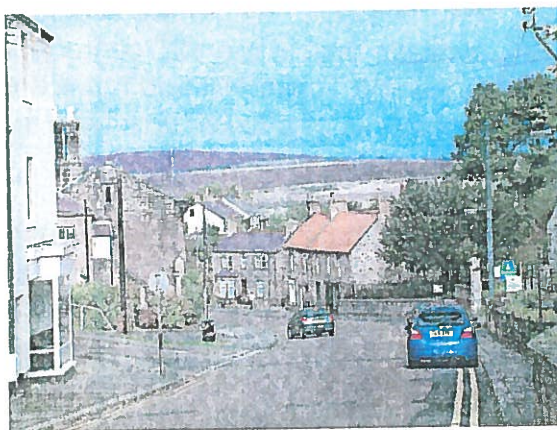
Church Street is a picturesque scatter of buildings, irregularly spaced, only loosely related to the road, which curves down through trees to the river with fine views of the Cheviot Hills beyond.

Church Street, a picturesque scatter of buildings

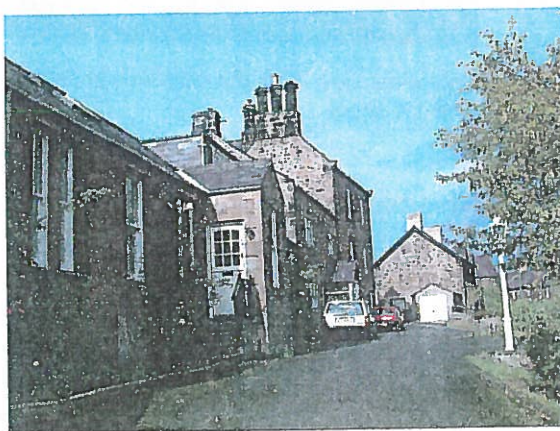
Of particular historic interest is the 2 storey stone built 'Rechabite Hall' dated 1842.

The former Rechabite Hall

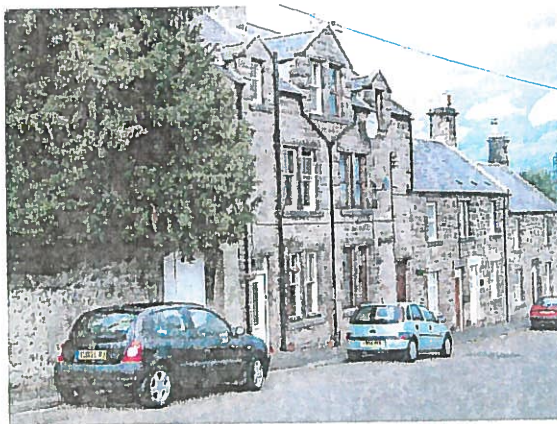
Ramsey's Lane – buildings with varied rooflines

A particularly fine group of 19th century buildings create a memorable composition. Although of plain stone, they have a variation in roofline resulting from stepping up the hill which is further emphasised by a change in height from 2 to 2 ½ storeys. The roofscape is enlivened further by gable dormers piercing the roof.

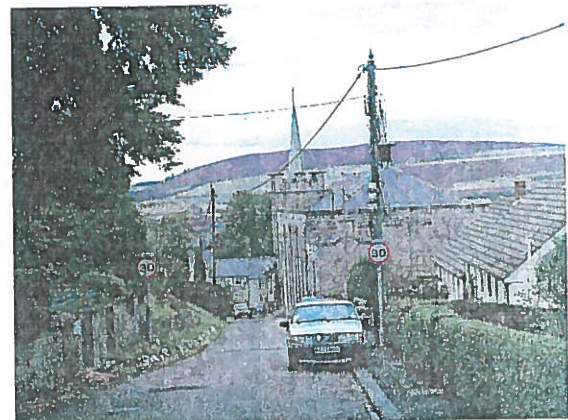
Ugly wirescape mars the picturesque setting of Cheviot Street

This picturesque view is marred by ugly wires, a serious problem throughout Wooler. Cheviot Street to the south, changes character, to a suburban scene with its well-clipped hedges and modern houses, and soon undergoes a further transition to a rural

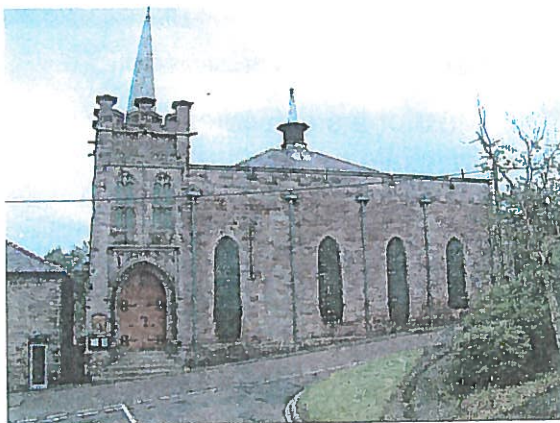
The old cottages that define the street scene are mostly 2 storeys high and are of a plain vernacular style mostly built of stone with slate or pantile roofs and generally of simple rectangular plan form. A significant landmark in the townscape with its elegant needle spire is the listed United Reform Church which was built in the late 18th and early 19th century of ashlar stone with perpendicular style tracery. The Church also is the integral dominant feature in a group of 2 storey stone cottages.

The United Reform Church, Cheviot Street

balusters, and contrasts with the plain facades found elsewhere in the street scene. Also the listed late 18th century United Reform Church on Cheviot Street has ornamentation with its perpendicular moulded windows and distinctive carved stone gargoyles. The Church of St Mary has carved gothic detailing and Tudor styling added at a later date.

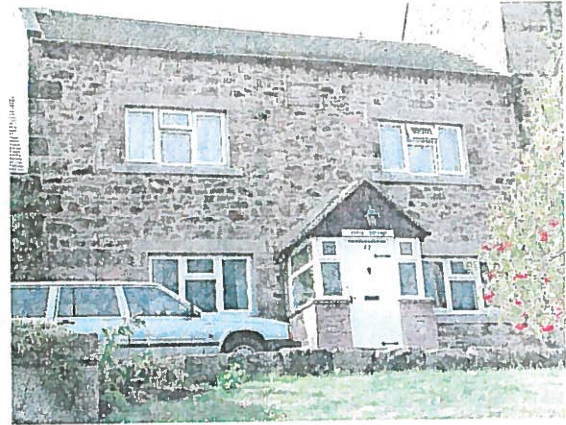
Random Rubble on Rechabite Hall, Tenter Street

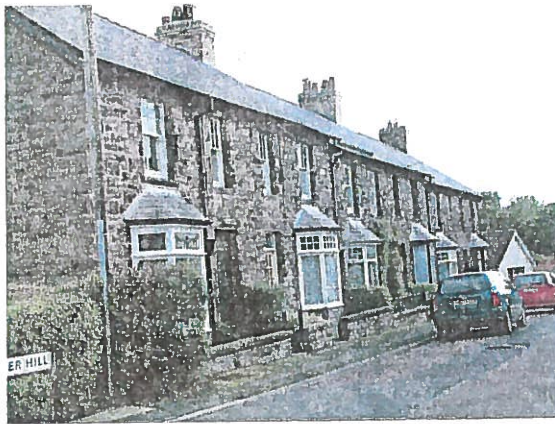
Rock faced stone finish on cottages on Tenter Hill

Surface finishes to the stone have a remarkable variety, for example hammer finish or rock faced, which give a rugged effect. These finishes can be seen on Tenter Hill and Glendale Road and are sometimes used for quoins. Other finishes found are punched, giving small holes or droved giving a series of straight lines. Squared quoins used on the corner of buildings are sometimes rusticated as are alternating blocks around openings. Stone mullions and reveals around openings usually of some depth have splayed corners particularly on late 19th century buildings.

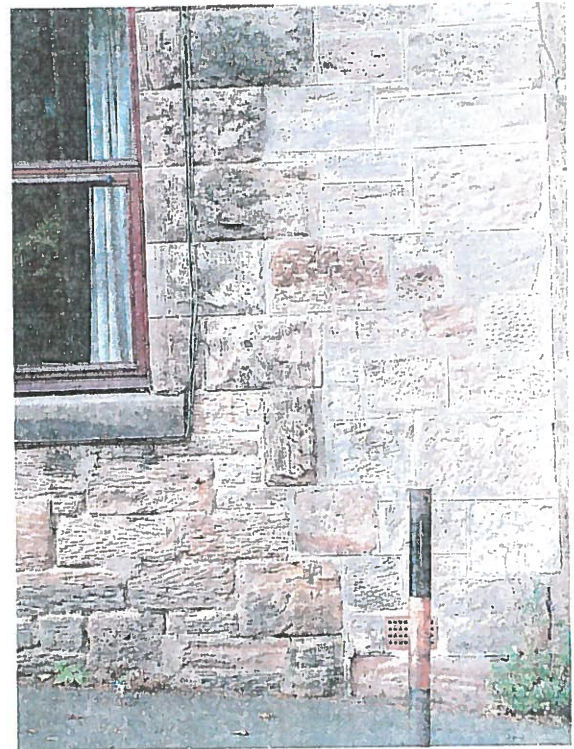
Snecked stone square block coursing

On earlier work particularly vernacular buildings random or coursed rubble is common but with squared quoins on corners and alternating squared blocks around openings. Boundary walls are usually built of random rubble with squared blocks on corners and openings, often with splayed, semi-circular or cock and hen coping.

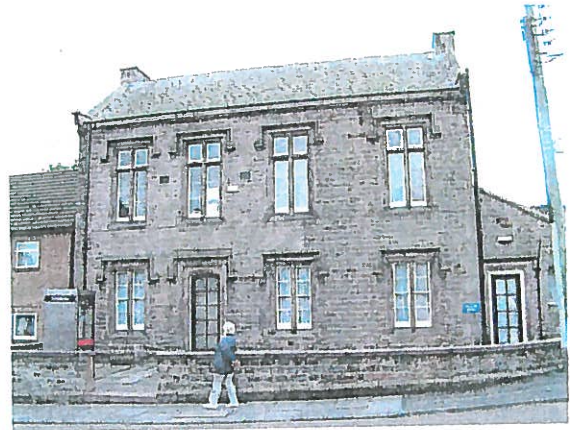
Carved hood moulds on Old Register Office 1859. These are a distinctive feature in Wooler

Other common stone features include protective hood mouldings over windows and doorways. Carved brackets over doors or windows are found occasionally.

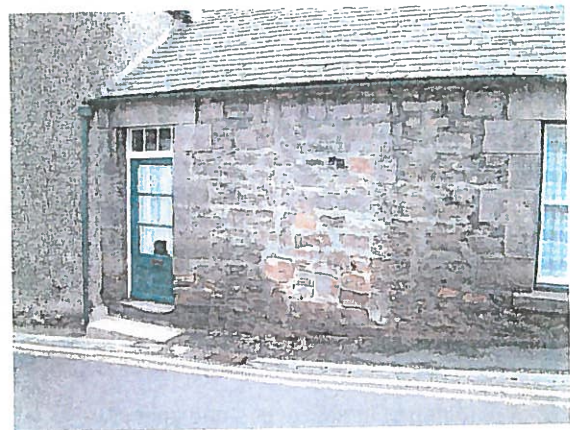
Blocked in doorway Ramsey's Street

Changes and modifications to stonework over the years can still be identified. These illustrate changing needs for the buildings. Examples include the blocking in of original doorways usually where two small cottages have been combined to form a larger dwelling, to cater for today's greater spatial requirements. Also, the blocking in of openings in boundary walls where the original function has changed.

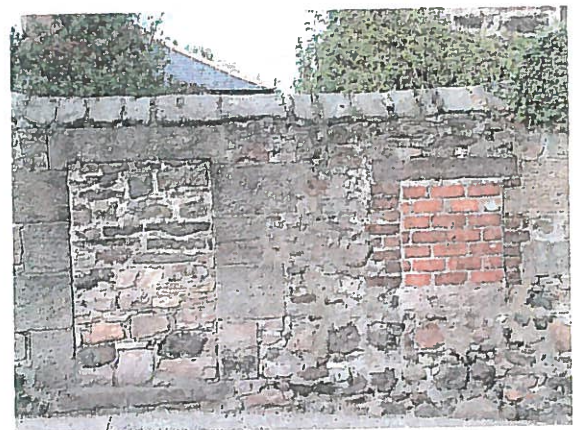
Blocked in openings in boundary wall.

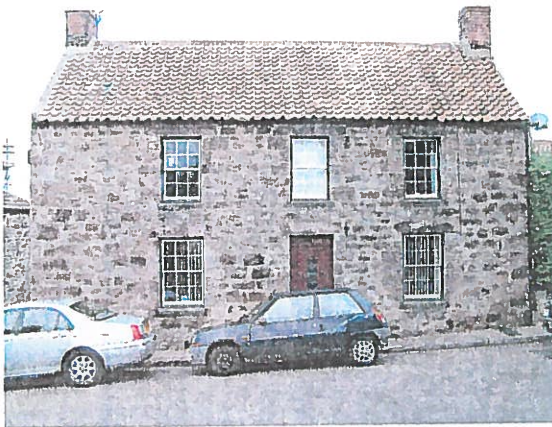
A buttering of mortar over stone arrises.

Another intrusive feature commonly found on old stone buildings is the repointing of stonework with hard cement mortar and using the wrong kind of joint, either buttering over the arrises or using ribbon pointing. This is not only aesthetically inappropriate but may eventually damage the stonework. Pointing should be carried out with a lime/sand mix with flush or concave pointing, depending on the kind of stone and tooling used.

11.2 The satisfactory repair and maintenance of old buildings requires expertise in the use of traditional materials and detail. This is sometimes lacking, for example, the use of cement mortar, with ribbon pointing, instead of a lime based mix, and concrete lintels instead of stone replacements.

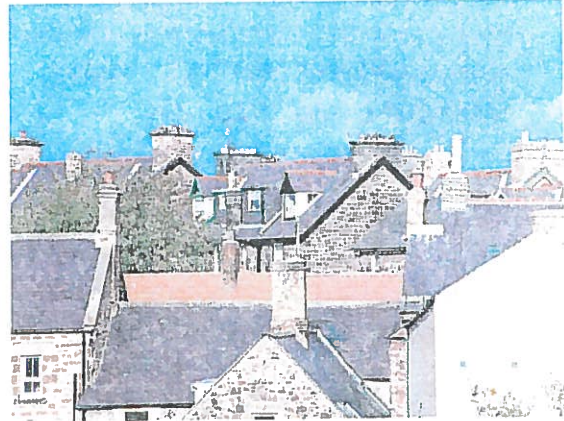
Wooler's attractive roofscape

Colours of the slate vary from a dark grey, grey/blue to a purple tinge. Original ridge pieces are usually of clay in dark grey or terracotta either with a v-ridge or hog's back shape with half-round ridges for pantile roofs.

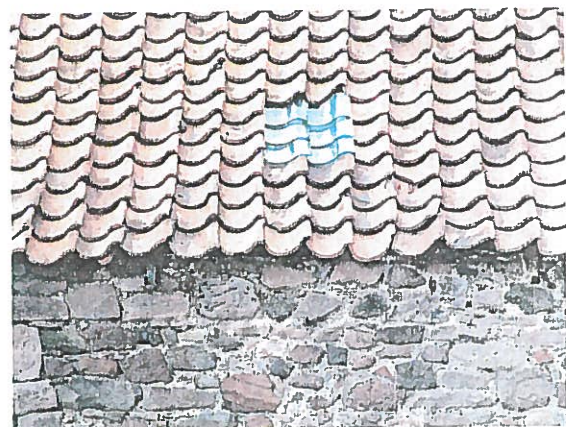
A pantile roof with pantile shaped glazing.

Pantiles are often used on industrial or agricultural buildings for example, old mill buildings on South Road, often with larger spans and shallower pitches than slate roofed residential properties. The terracotta clay colour gives an attractive warm contrast to the cooler greys and blues of the slate.

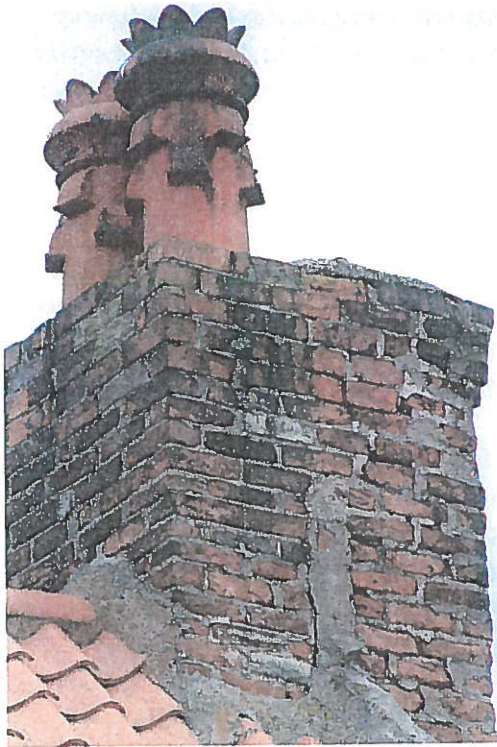
High Street – an unusual ornate Gaudyesque chimney pot

The stacks are a mixture of original stonework or brick, and pots are in a variety of forms including the simple cannon type and are mostly of clay.

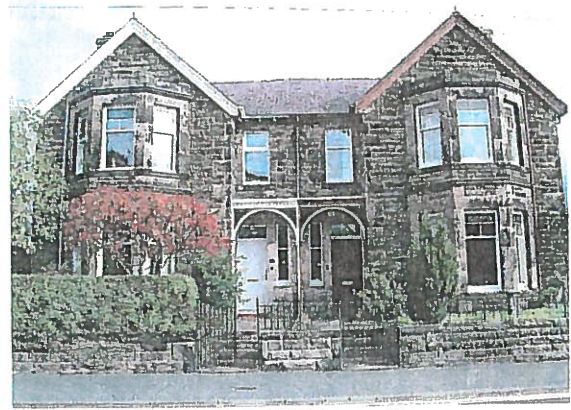
Gables adding variety and modelling to the street scene

There are sometimes flat, stone copings used as a finish to gable end walls and occasionally with a neat, curved projecting stone curve to the base of the gable at eaves level known as a 'kneeler'.

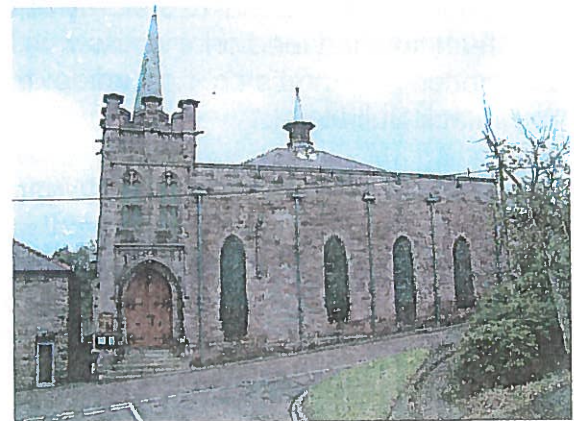
Elegant needle spire on United Reform Church, Cheviot Street

Ecclesiastical buildings often have prominent roofs which are landmarks in their own right, for example the United Reform Church on Cheviot Street with its elegant needle spire. St Mary's Church has a four-storey high tower and spire.

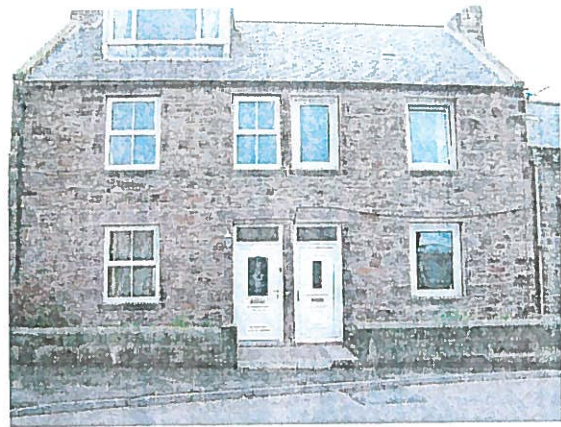
PVCu windows and doors

Many traditional buildings in Wooler have suffered serious erosion of their historic character because of the removal of original sash windows and replacement by inappropriate designs or materials such as PVCu plastic.

There have been many PVCu or replacement windows with stained finish in inappropriately designed pastiche Georgian or Tudor-bethan replacements which generally detract from the architectural and historic character of not only the building but the whole street scene.

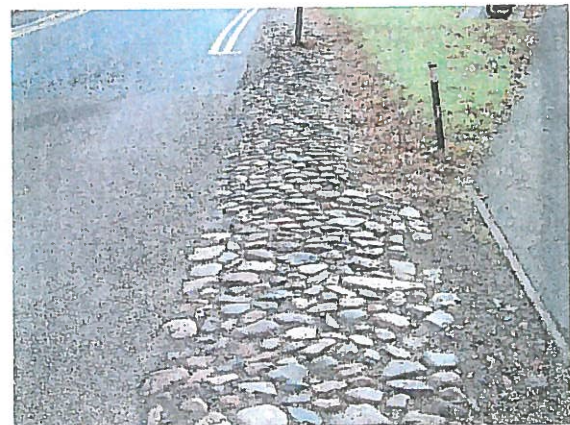
Cobbles on Ryecroft Way

Little original cobbling has been observed in Wooler apart from a narrow strip of cobbles along part of Ryecroft Way. 'Marshall's' concrete paviors have been used on the pedestrian access to Archbold Cottages off Church Street which are a reasonable match for general colours in the vicinity.
